# ROOF FLASHING

## DETAILING FOR TILED ROOFS

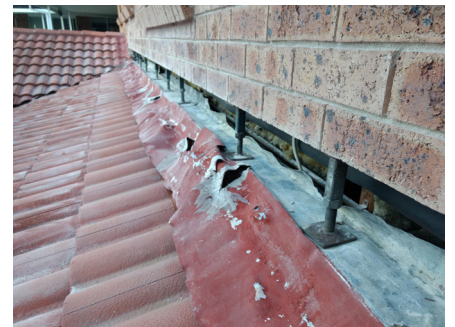
Figure 13: Straight Flashing Damaged Due To Poor Installation

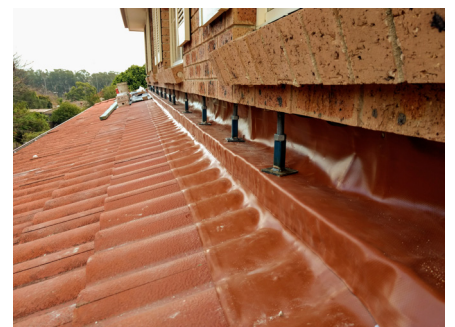
Figure 14: Straight Flashing Reinstallation
